CULTURAL RESOURCES SURVEY FOR A JOINT TASK FORCE SIX (JTF-6) ACTION IN WEBB, MAVERICK, AND DIMMIT COUNTIES, TEXAS

for
**U.S. Army Corps of Engineers
Fort Worth District**

**MISCELLANEOUS REPORT OF INVESTIGATIONS
NUMBER 158**

March 1998

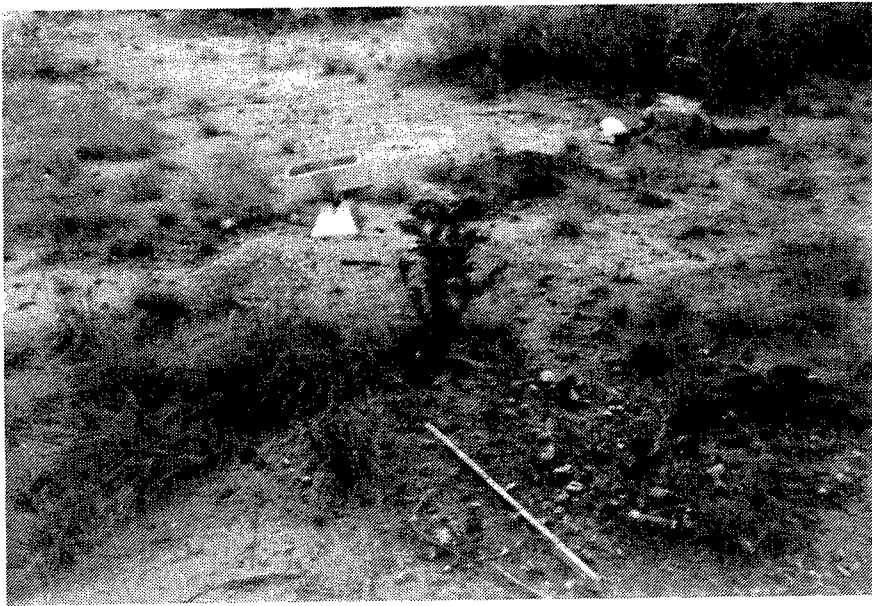
Figure 28. View of hearth feature at site 41WB482 (facing north).

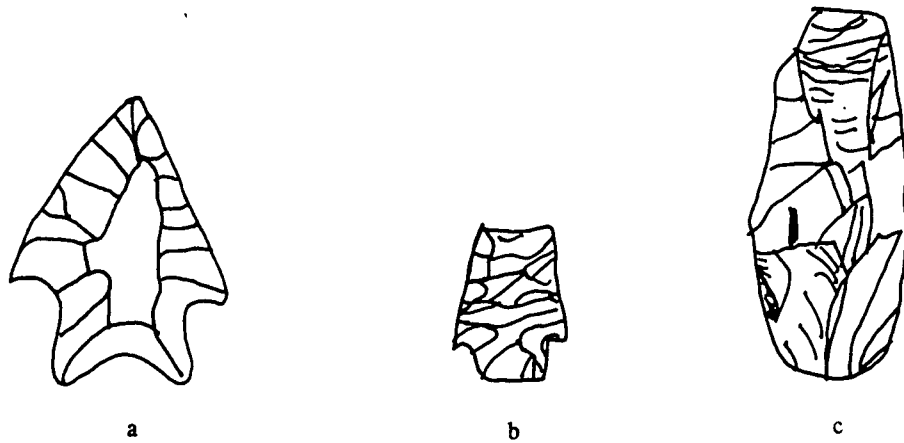
Figure 35. Field illustrations of projectile points identified at site 41WB487: (a) Gower point; (b) Refugio point; and (c) Palmillas point (Scale 1:1).

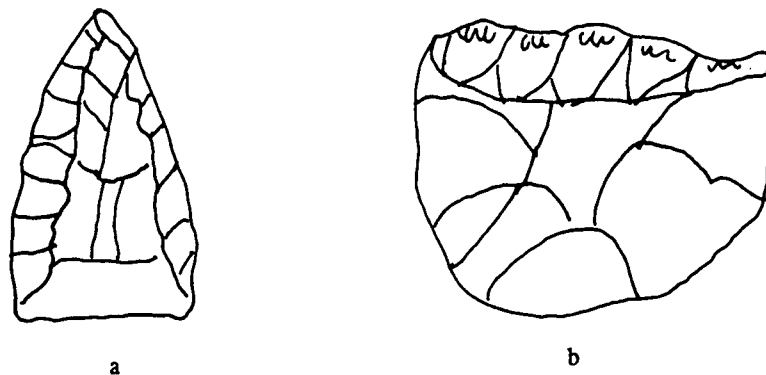
Figure 37. Field illustrations of artifacts identified at site 41WB488: (a) the Early Triangular/Tortugas/Matamoros-type point and (b) possible Nueces biface (Scale 1:1).

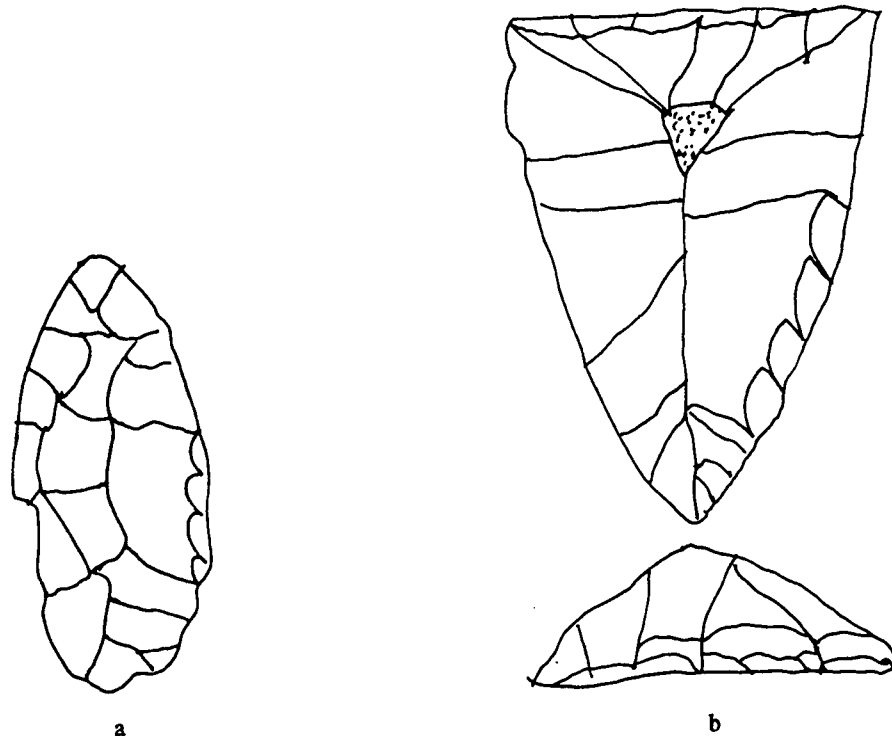
Figure 59. Field illustrations of artifacts identified at site 41WB509: (a) Catán/Refugio-type point and (b) a Clear Fork uniface (Scale 1:1).

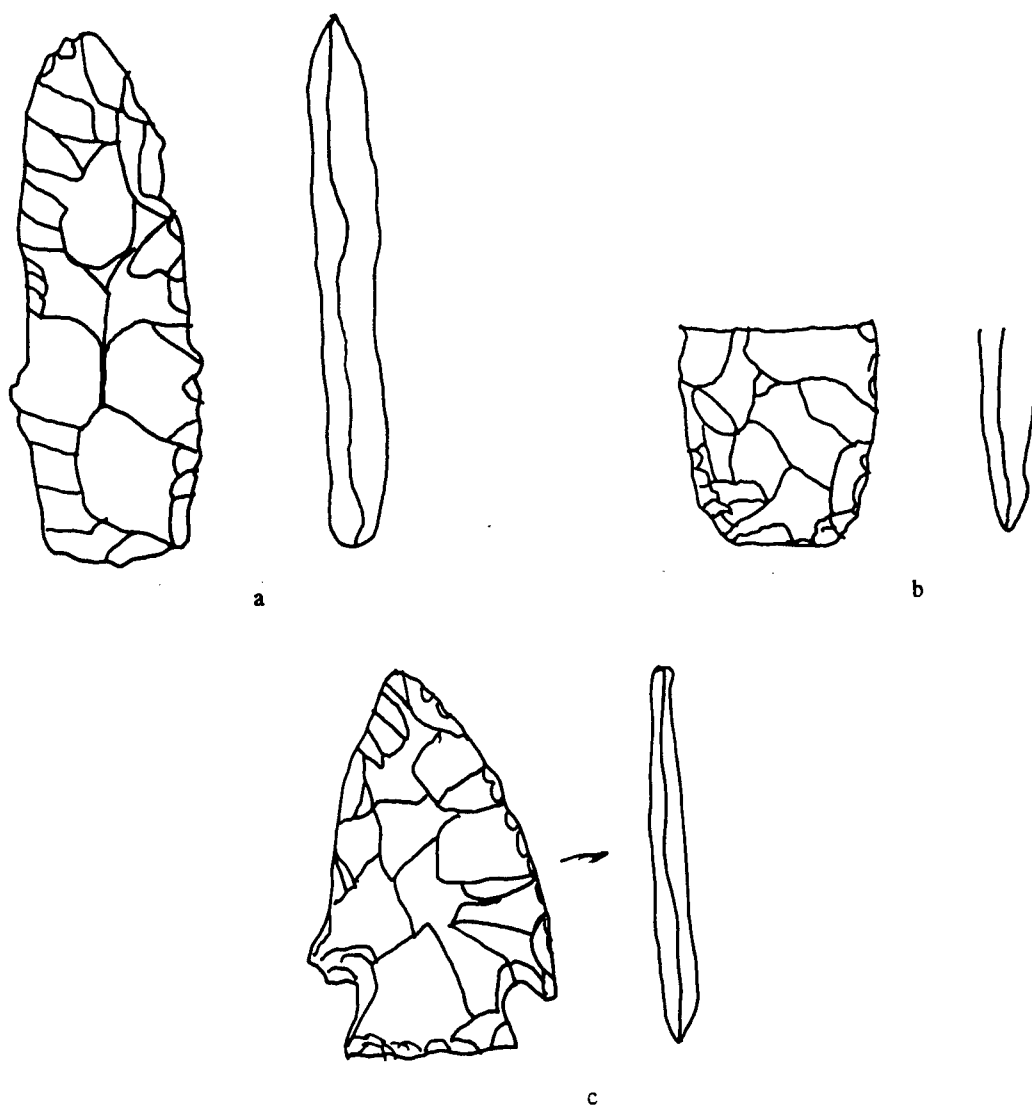
Figure 98. Field illustrations of projectile points identified at site 41MV209: (a) Pandora point; (b) Pandora point; and (c) Lange point (Scale 1:1).

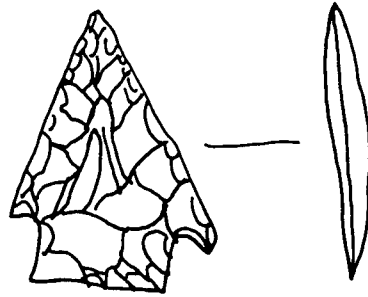
Figure 104. Field illustration of a Lange projectile point identified at site 41MV211 (Scale 1:1).

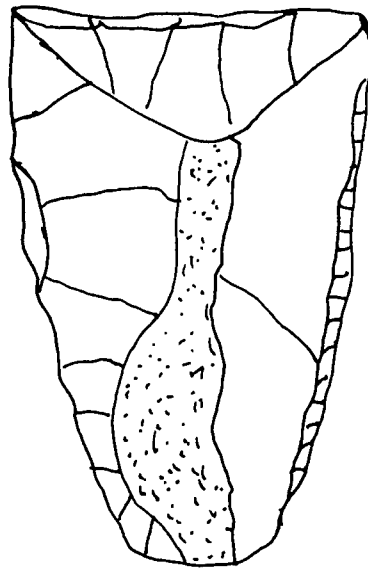
Figure 112. Field illustration of Clear Fork uniface identified at site 41MV216 (Scale 1:1).
